TECHNICAL MEMORANDUM

TO: RACHEL CALABRO, RIVERWAYS PROGRAM TAUNTON RIVER WILD & SCENIC LIAISON
FROM: BRIAN GRABER, FLUVIAL GEOMORPHOLOGIST, RIVERWAYS PROGRAM
SUBJECT: TAUNTON RIVER ASSESSMENT
DATE: 12/14/2004
CC: JOAN KIMBALL, RIVERWAYS PROGRAM DIRECTOR

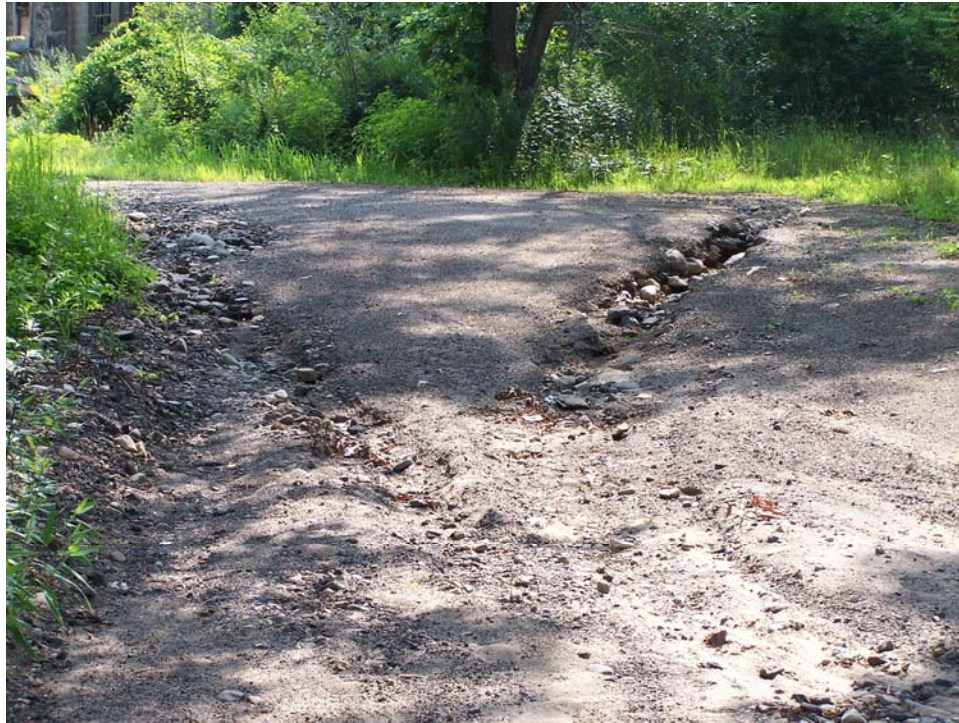
- Town River Dam (AKA High Street Dam)
 - At the Bridgewater Highway Department
 - Really 2 dams with a fish ladder
 - Fish ladder on upstream structure appears to be a barrier at lowflow – perched on both upstream and downstream ends – may be passable at high flows
 - Significant hazard dam in poor/fair condition
 - Inspected in 1998 and no repairs have been made
 - Dirt road is eroding into the river here

Figure 2. Dirt Road eroding into river at Bridgewater Highway Dept

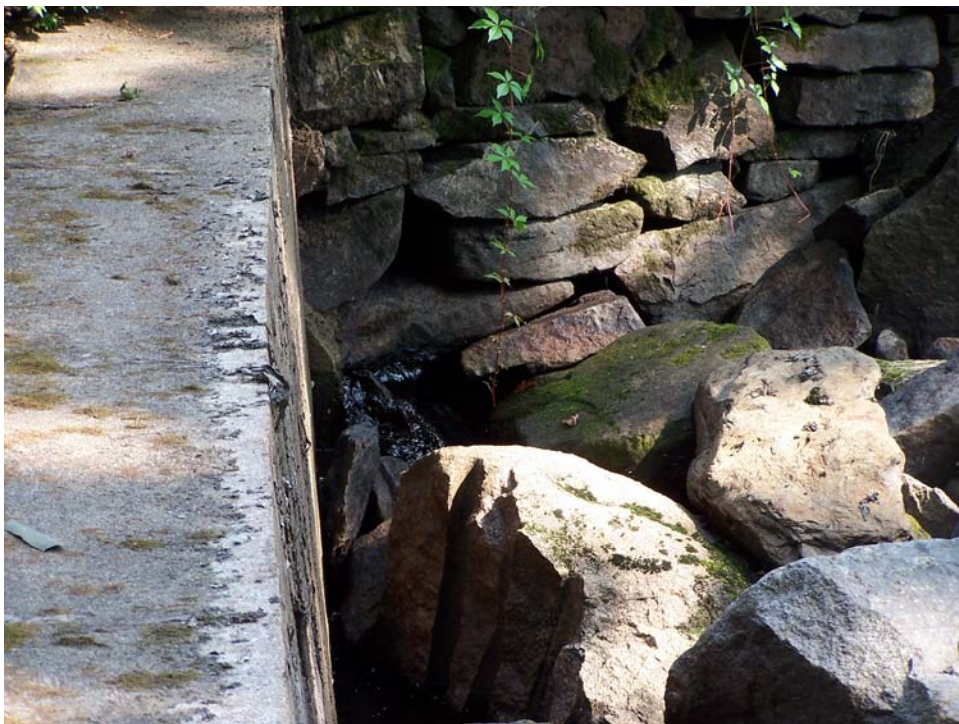
Figure 4. Seepage through War Memorial Dam

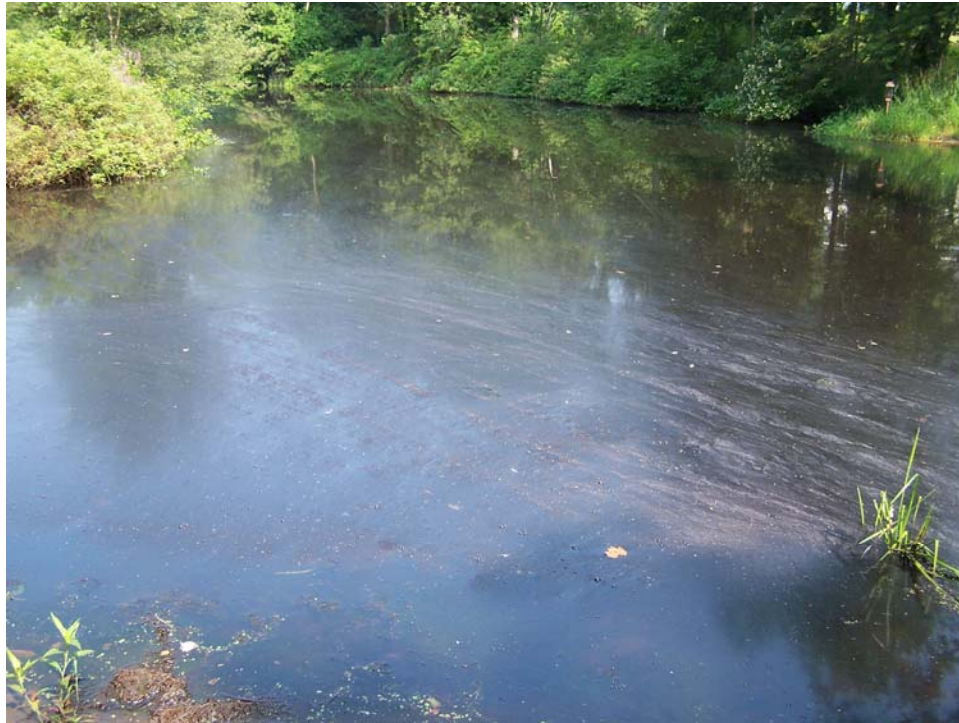
Figure 5. Organic material on water surface of War Memorial Dam impoundment

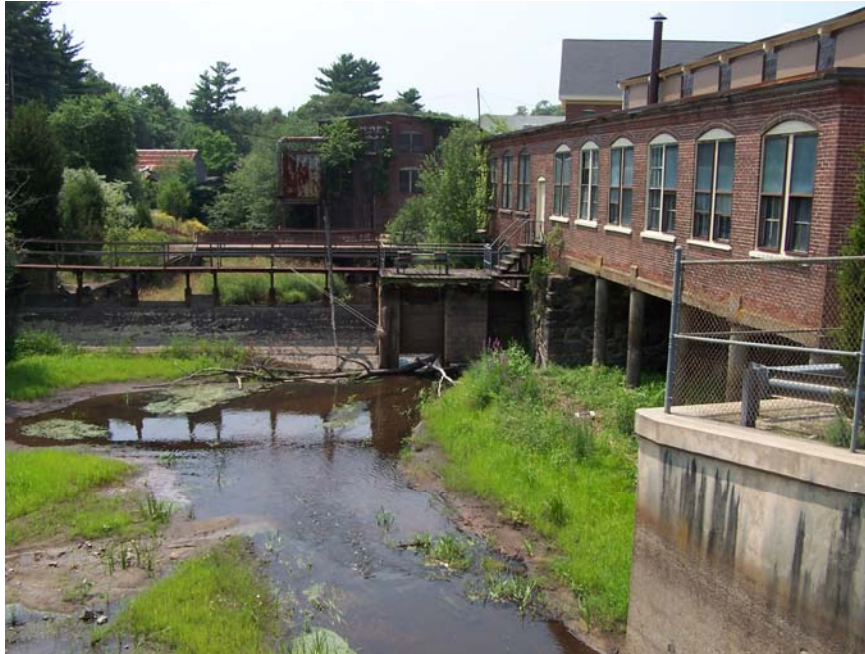
- Meadow Brook
 - Forge Pond Dam
 - Fish ladder is in poor condition and is not passable
 - Just downstream is a culvert/dam at Willow Ave that is impassable at low flow
- Satucket River
 - Cotton Carver Dam
 - Dam has breached and impoundment drained
 - Its removal would open up a large amount of habitat and many tributaries. Only one of the tributaries has a dam (Robbin Pond)

Figure 6. Cotton Carver Gin Mill Dam

- Owner is amenable to removal and towns are also in support – primarily need funding to proceed
- The mill building would make a nice riverside structure for a restaurant or some other business (I'd like the Cotton Carver Combo light on the mayo)
- Army Corps is beginning a Section 206 feasibility study
 - Project will be expensive and time-consuming with Corps involved
 - Could get out of the 206 and pursue other funding?

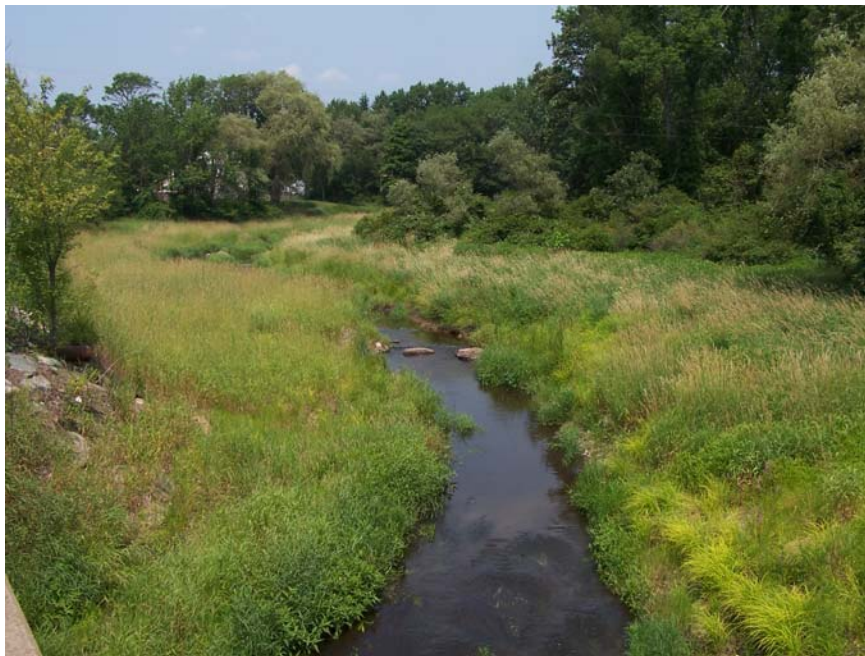
Figure 7. Channel forming in impoundment of Cotton Carver Dam

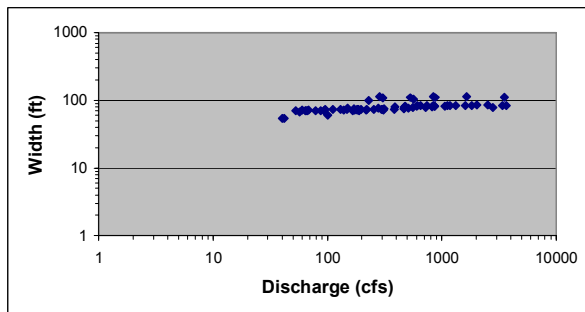
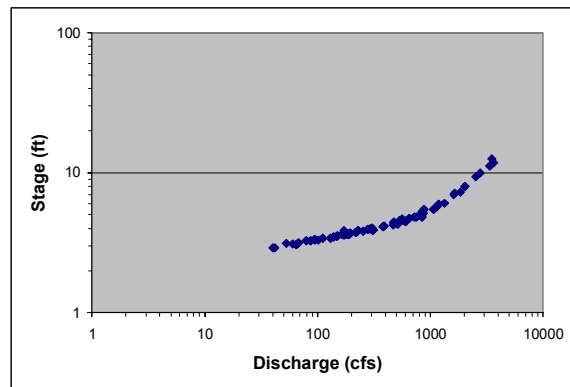
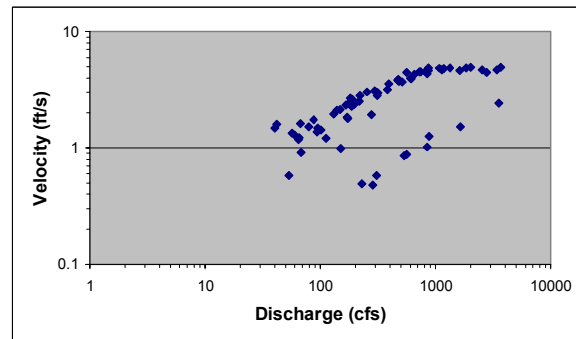
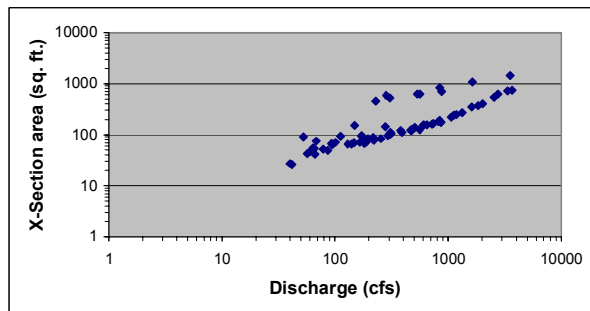
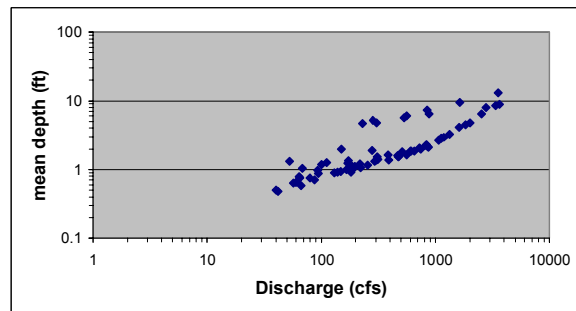
Figure 10. Preliminary bankfull estimates at the USGS Taunton River gauge

Figure 10 includes a flood frequency analysis, lowflow information, and preliminary bankfull estimates computed from USGS gauge data. ‘Bankfull’ refers to the surface where water first spills out onto the floodplain in more natural river reaches. Identifying bankfull on a degraded reach can show the degree of incision or deposition. For example, on an incised reach, bankfull will occur below the top of the banks. Bankfull typically occurs at the level of frequent floods between approximately the 1.2- to 2-year floods.

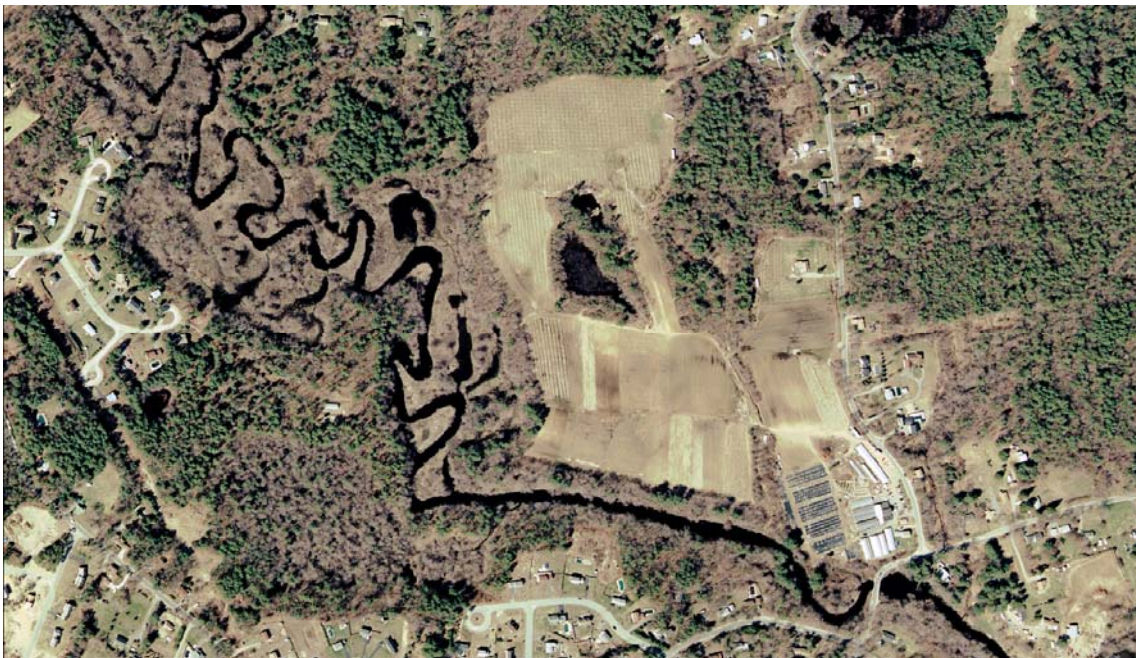
A recent Stream Team Shoreline Survey identified excessive bank erosion in the Matfield River upstream of Bridge Street. An air photo, shown below, provides some clear evidence about the cause of the erosion (Figure 11). Note the highly sinuous meandering pattern of the river in the upper left portion of the air photo. This highly sinuous pattern is naturally characteristic of low gradient broad floodplain rivers like this portion of the Matfield. However, the river continues through a much straighter reach as it approaches Bridge Street, which crosses the river in the bottom right portion of the air photo. This portion of the river was straightened at some time in the past, possibly to help drain water from agricultural fields or simply to move the river out of the way for farming. Channel straightening typically results in long-term erosion, as the same amount of water now flows over a shorter distance with less form resistance and therefore carries more erosive power than the same water winding through the meandering stretches. The channel here on the Matfield is gradually eroding to reform its meandering pattern. The river is preferentially eroding local outside bends and depositing on the inside of bends. This process contributes additional sediment to the river and will continue potentially for many years. Additional measurements would be necessary to estimate the quantity of sediment that is ending up in the river and thereby determine whether this erosion is significant on a watershed scale. Based on visual assessment, the Matfield does appear to carry greater suspended sediment than other tributaries, but this may result more from Brockton runoff.

Figure 11. Air photo showing meandering and straightened portions of the Matfield River

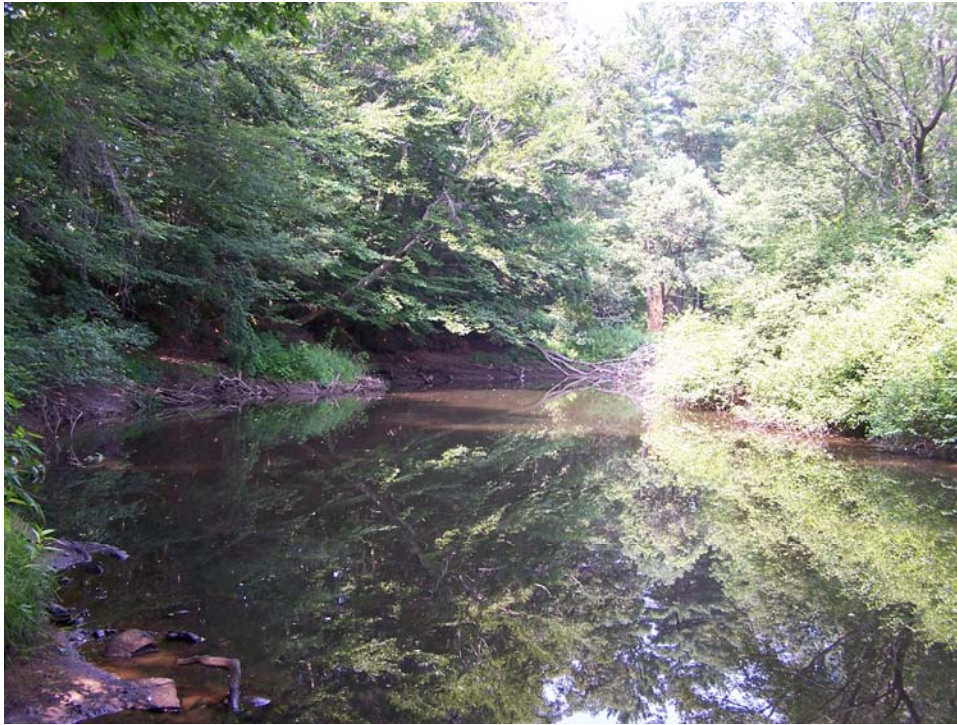
Figure 12. A portion of the Matfield River showing bank erosion at the downstream end of the straightened reach. Note particularly under the trees in the background.
